HURRICANE FLORA DAMAGE TO THE CUBAN TRANSPORTATION SYSTEM REPAIRED RAPIDLY

CIA/RR CB 63-96

29 November 1963

CENTRAL INTELLIGENCE AGENCY Office of Research and Reports

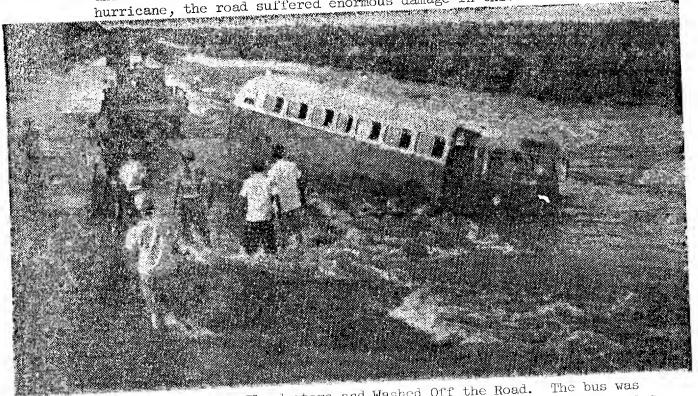
Figure 4. Bus Picked Up by Floodwaters and Washed Off the Road. The bus was washed off the road while trying to aid in the evacuation of the area around Cama-
